220 Shaw Street, Toronto, Ontario

SUMMARY INSPECTION REPORT

INSPECTION REPORT

PROPERTY: 220 Shaw Street, Toronto, Ontario

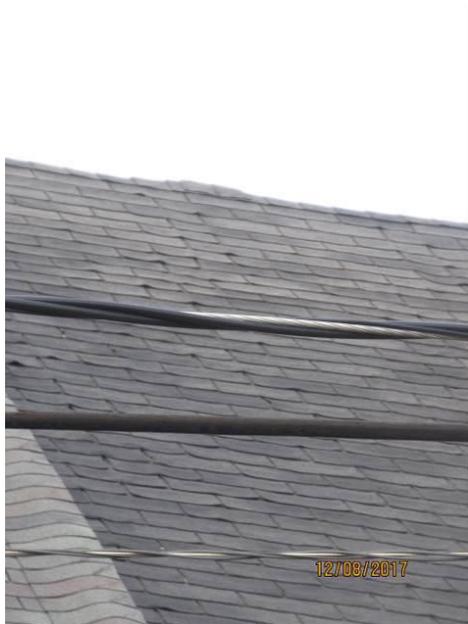
2.03A Asphalt roofing shingles: Typically, this type of roofing material will last 15-20 years. Slopes that face south and west receive more sunlight and generally wear faster. The asphalt shingles on north slope at the rear were installed less than seven years ago and are in good condition. The shingles on the east and west sides are old and were installed more than fifteen years ago. The age/condition of the shingles below the second floor deck are unknown.

M/P: as the shingles on the east and west sides above the second floor are near the end of their functional life, replacement is recommended in the next two years. Though the shingles on the front peak that face north and south are in much better condition, one would typically replace these shingles at the same time.

(Approximate Cost: \$7,000 to \$10,000)

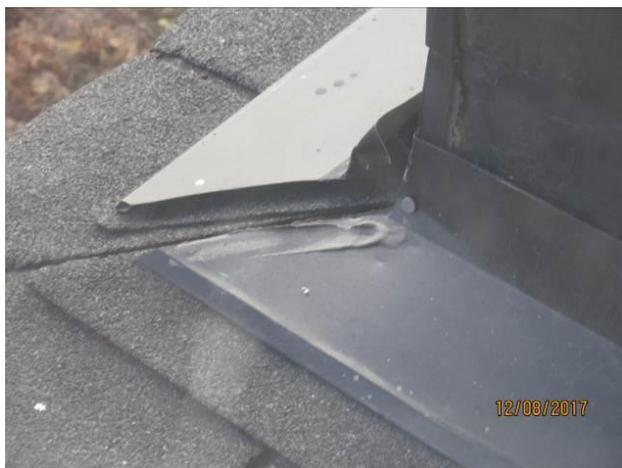
P: there are some gaps in the trim-work below the front second floor sunroom windows that should be made watertight. As well, some of the metal flashing detail on the roof overhang below these windows is not properly sealed.

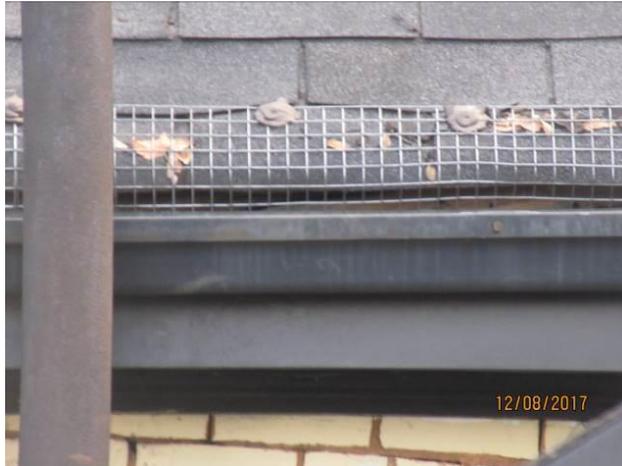
M: repairs have been made with wire mesh to several holes in the eaves at the front and rear as a result of past wildlife activity. Ensure that the repairs remain well sealed. You may want to do a permanent repair in future for cosmetic reasons. This would typically be done when the roof shingles are replaced.
